INVENTORY FORM FOR STATE HISTORIC SITES SURVEY

Pennyworth Tenant House

West bank of Thompson Creek, Kent Point Road (MD RT 9)

QA-285

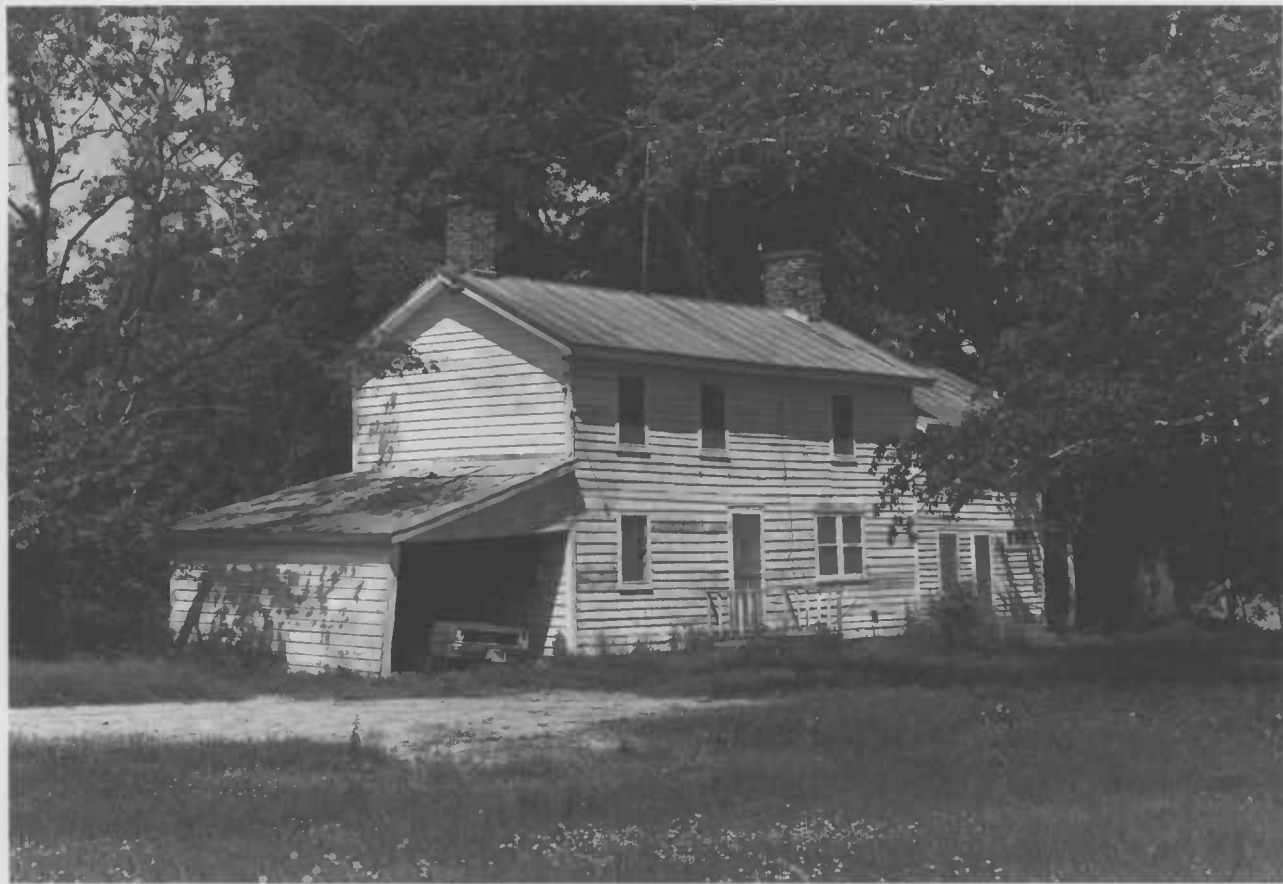
QA-285 Pennyworth Farm Tenant House
Stevensville vicinity
Orlando Ridout V 1980
Front facade

The front facade of the main house is asymmetrical, with a door near the center on the first floor flanked by a single 6/6 window to the left and a paired 6/6 to the right, and three 6/6 windows ranged across the second floor. The building rests on a concrete block foundation and is covered with plain weatherboard siding and plain cornerboards. The eaves oversail and are boxed in; the roof is standing seam tin.

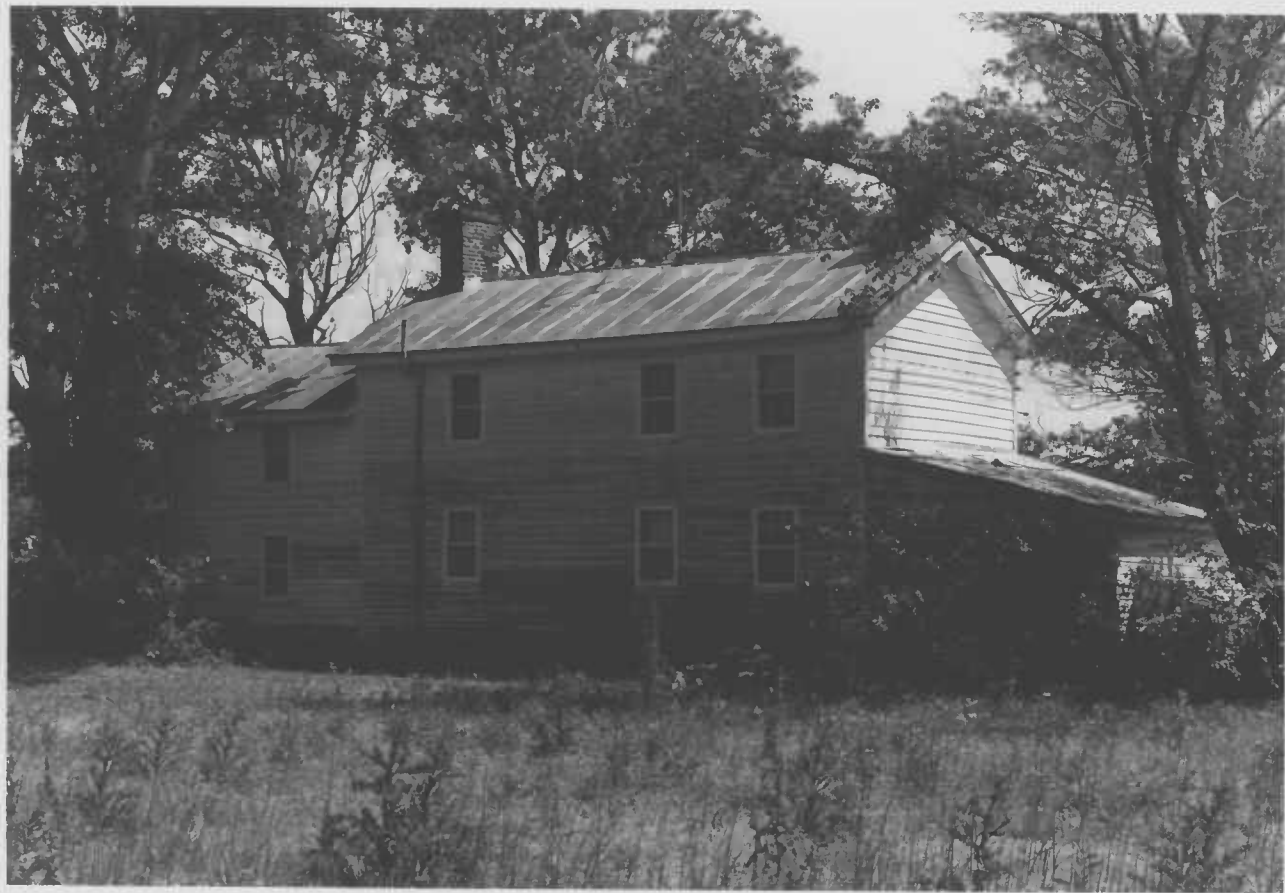
QA-285

Pennyworth Farm Tenant House
Stevensville vicinity
Orlando Ridout V 1980
Rear facade

The rear facade is essentially broken up into four bays with the second bay from the east not expressed and three 6/6 windows on each floor. The siding, cornice and roof all match the front facade.
